LANDSAT TM-BASED ANALYSIS OF LAND AREA AND VEGETATION COVER CHANGE ON SIX
SELECTED ALABAMA AND MISSISSIPPI BARRIER ISLANDS (1984-2011)

A THESIS

Submitted in partial fulfillment of the requirements
for the degree of Master of Science
in the Department of Geography
in the Graduate School of
The University of Alabama

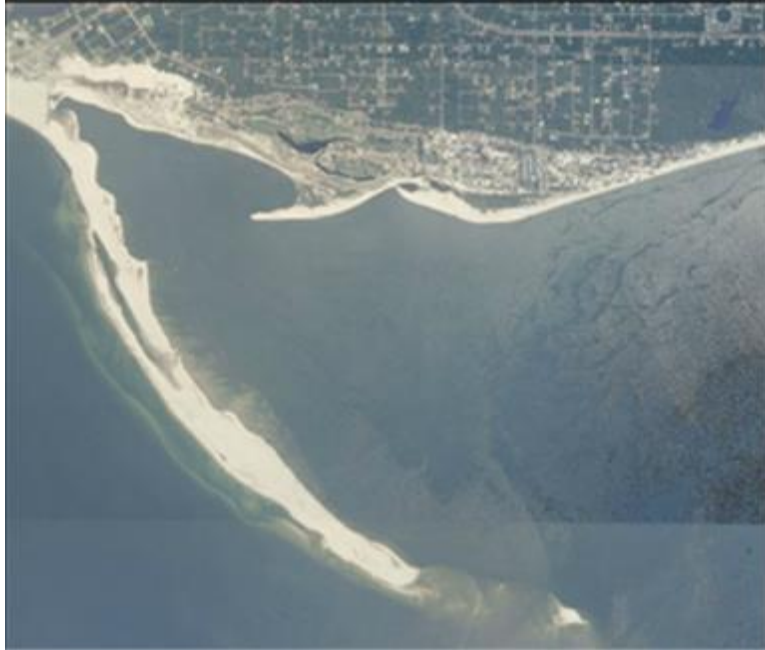
Figure 2: Aerial photograph from 2009 showing Pelican-Sand Island connected to Dauphin Island (University of Alabama Cartographic Research Laboratory 2012)

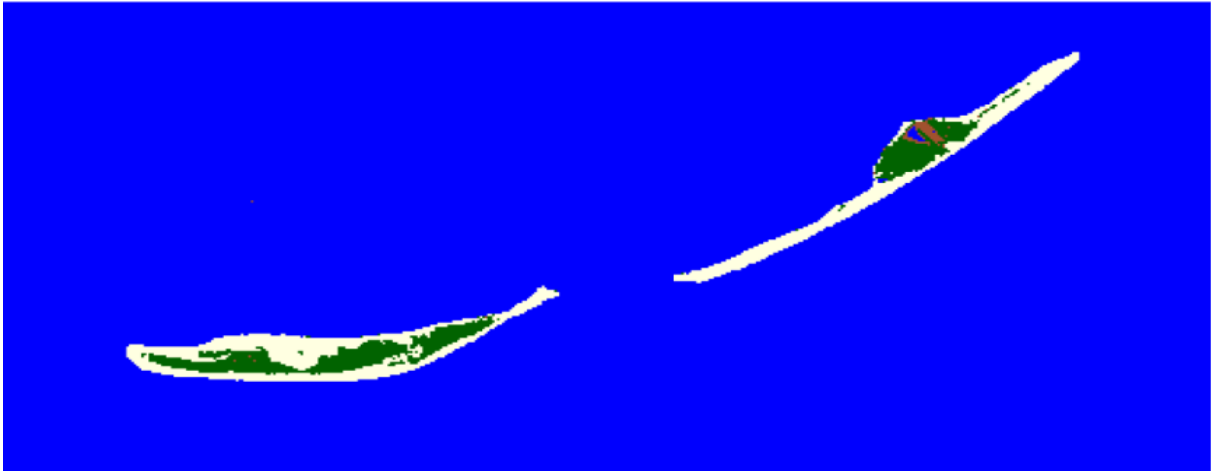
Figure 16: 1984 supervised classification of West and East Ship Island

Figure 17: 1992 supervised classification of West and East Ship Island

Figure 18: 1998 (before Georges) supervised classification of West and East Ship Island

Figure 19: 1999 (after Georges) supervised classification of West and East Ship Island

Figure 20: 2000 supervised classification of West and East Ship Island

Figure 21: 2004 (before Ivan) classification of West and East Ship Island

Figure 22: 2005 (after Ivan, before Katrina) supervised classification of West and East Ship Island

Figure 23: 2006 (after Katrina) supervised classification of West and East Ship Island

Figure 24: 2008 (before Gustav and Ike) supervised classification of West and East Ship Island

Figure 25: 2009 (after Gustav and Ike) supervised classification of West and East Ship Island

Figure 26: 2010 supervised classification of West and East Ship Island

Figure 27: 2011 supervised classification of West and East Ship Island

Similar to the area of pinus and shrubs and all healthy vegetation, the marsh on East Ship Island has experienced a significant decline (Table 14). The area of marsh on the island remained below the mean after Hurricane Ivan made landfall along the northern Gulf Coast (Table 15). Hurricane Katrina was the most devastating storm in terms of percentage of marsh loss on East Ship Island (Table 19). After the storm made landfall on the northern Gulf Coast, the area of marsh on East Ship Island was down 7.2 hectares (-90%) from its total in 1984. The island’s peak in marsh area was in 1998. After Hurricane Katrina, the island had lost 12.2 hectares (-93.85%) of marsh from its total in 1998. From 1984 to 2011, East Ship Island lost 7.2 hectares (-90%) of its total marsh (Figures 16-27).

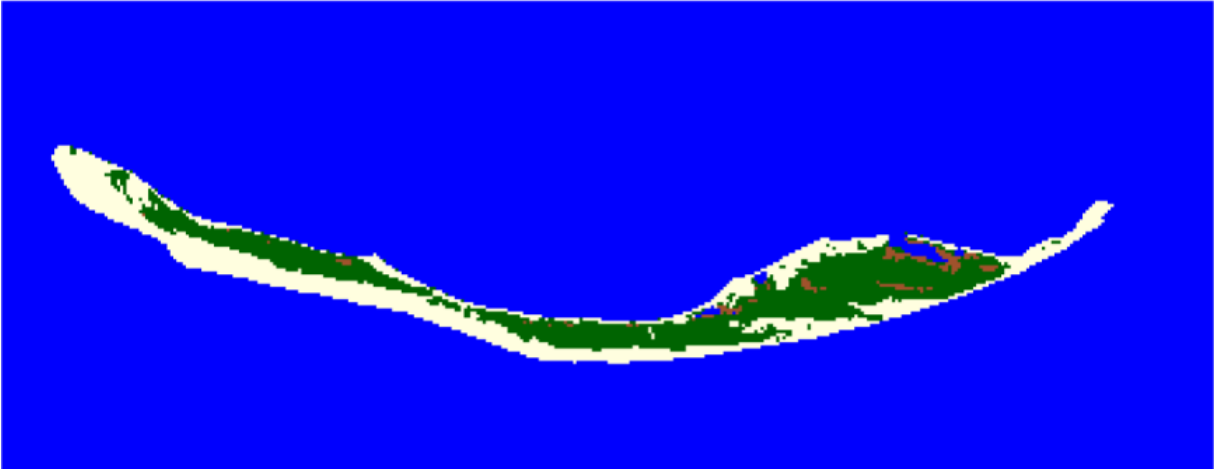
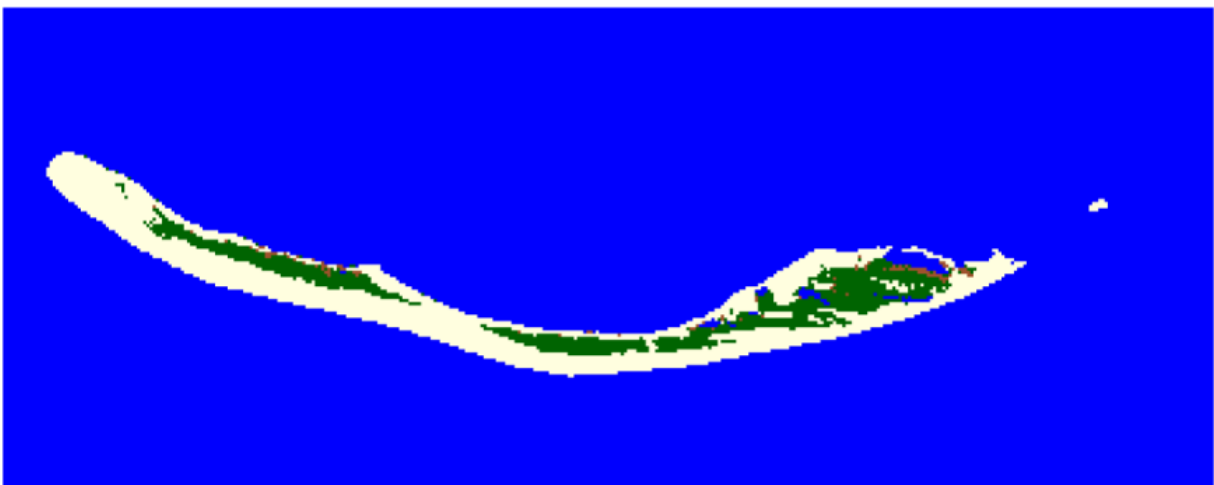
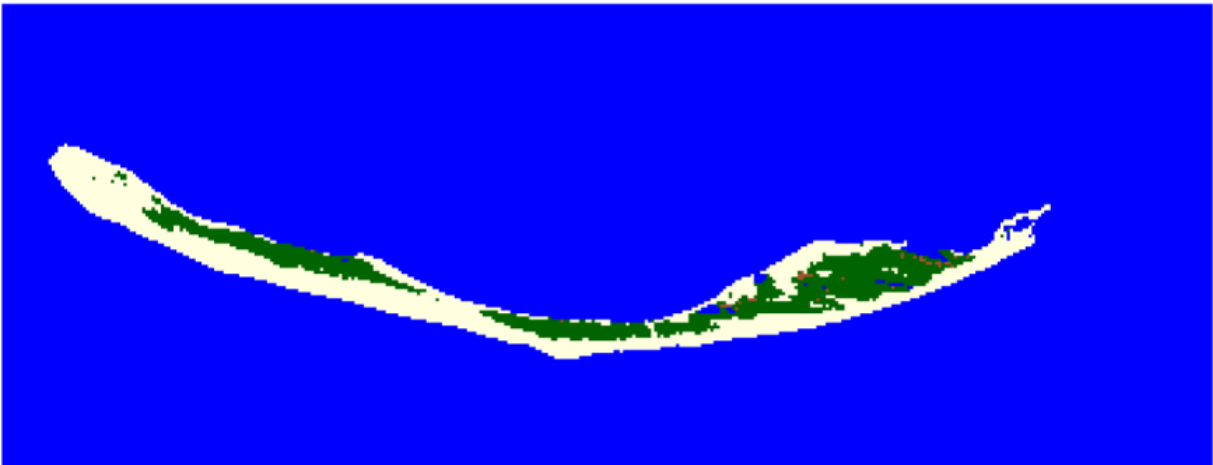
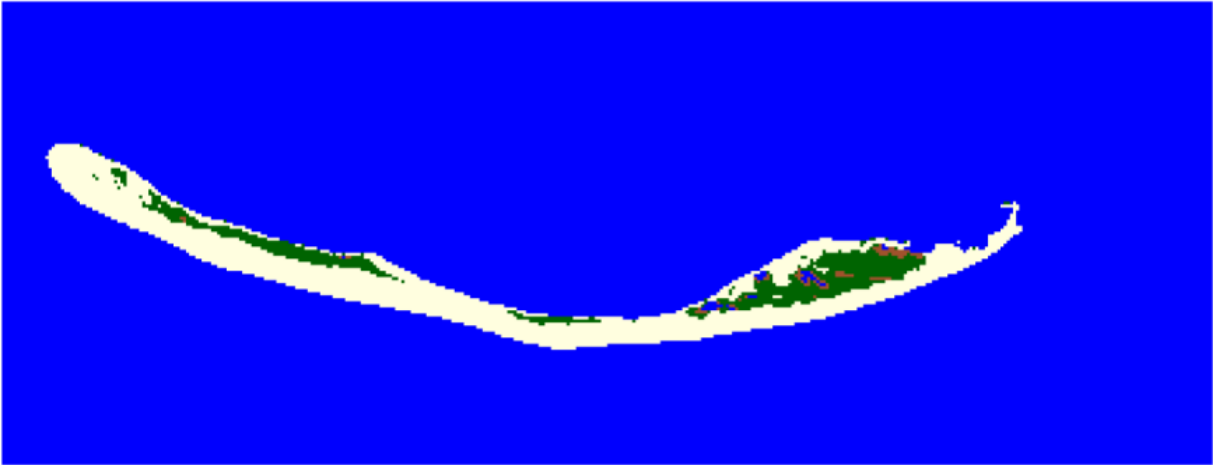
Figure 40: 1984 supervised classification of Petit Bois Island

Figure 41: 1992 supervised classification of Petit Bois Island

Figure 42: 1998 (before Georges) supervised classification of Petit Bois Island

Figure 43: 1999 (after Georges) supervised classification of Petit Bois Island

Figure 44: 2000 supervised classification of Petit Bois Island

Figure 45: 2004 (before Ivan) supervised classification of Petit Bois Island

Figure 46: 2005 (after Ivan, before Katrina) supervised classification of Petit Bois Island

Figure 47: 2006 (after Katrina) supervised classification of Petit Bois Island

Figure 48: 2008 (before Gustav and Ike) supervised classification of Petit Bois Island

Figure 49: 2009 (after Gustav and Ike) supervised classification of Petit Bois Island

Figure 50: 2010 supervised classification of Petit Bois Island

Figure 51: 2011 supervised classification of Petit Bois Island

Petit Bois Island has experienced fluctuations in its area of marsh throughout the study time period (Table 26). The area of marsh on the island remained completely below the mean after Hurricane Katrina made landfall along the northern Gulf Coast (Table 27). Hurricane Katrina was the most destructive storm in terms marsh area loss on Petit Bois Island (Table 31). After Hurricane Katrina devastated the northern Gulf Coast, Petit Bois Island's area of marsh was actually up one hectare from its total in 1984. However, after Katrina, the area of marsh on Petit Bois Island was down 10 hectares (-55.56%) from its pre-Katrina peak in 2005. From 1984 to 2011, Petit Bois Island lost four hectares (-57.14%) of marsh (Figures 40-51).

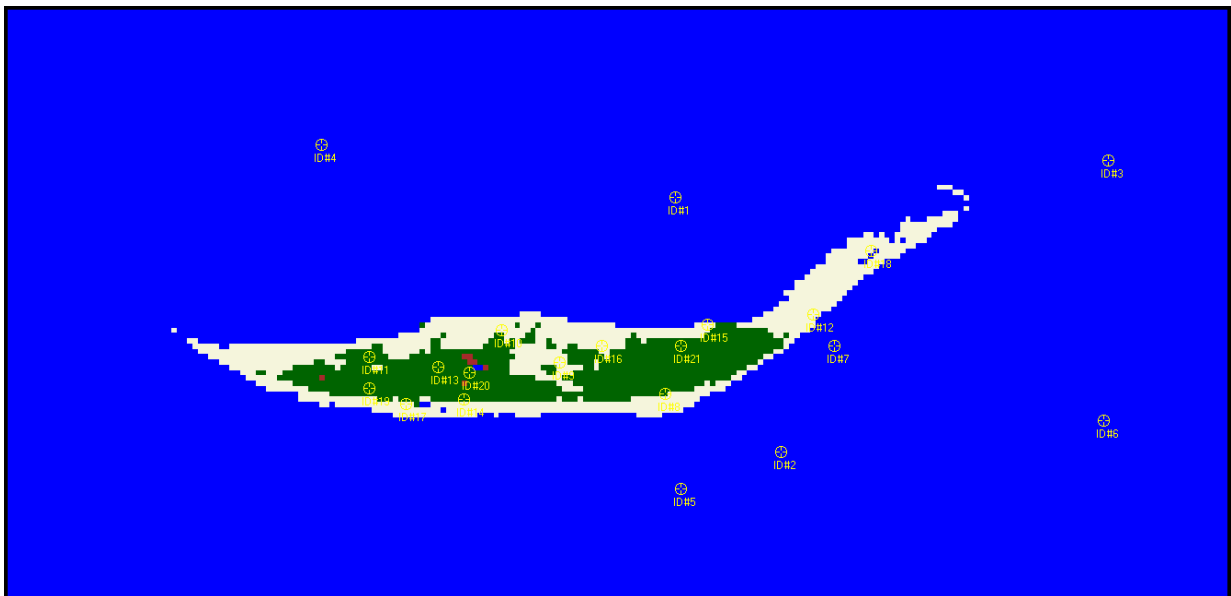
Figure 70: Accuracy assessment of the West Ship Island supervised classification image

Accuracy assessments reveal that 95% of the pixels in the subset September 14, 2010 Landsat 5 TM scene of West Ship Island were correctly classified (Table 45). The only sample point that was not classified correctly was in the pine/shrub class. The incorrectly classified pixel should have been in the sand class (Figure 70).

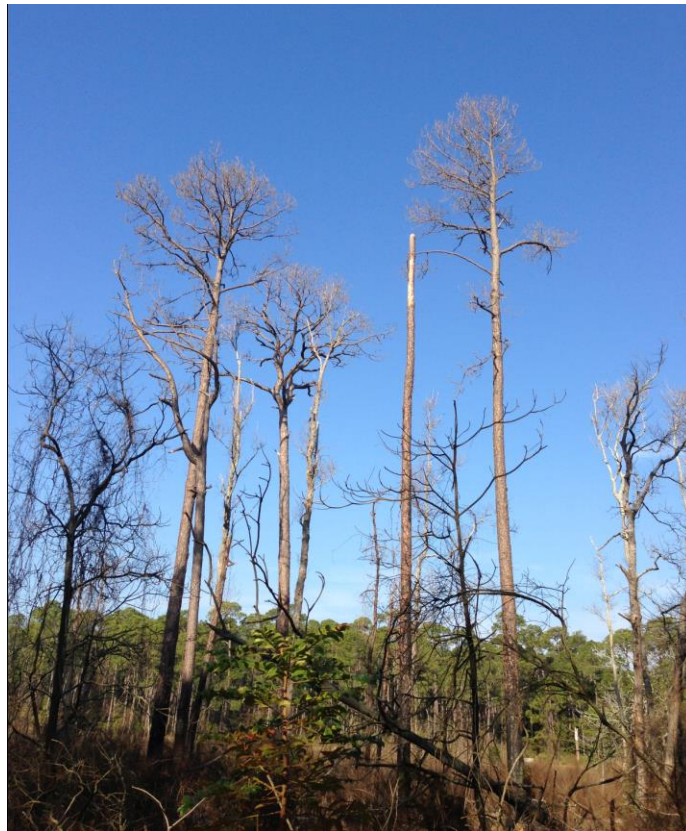
Figure 76: Dead pine trees in the bird sanctuary on Dauphin Island

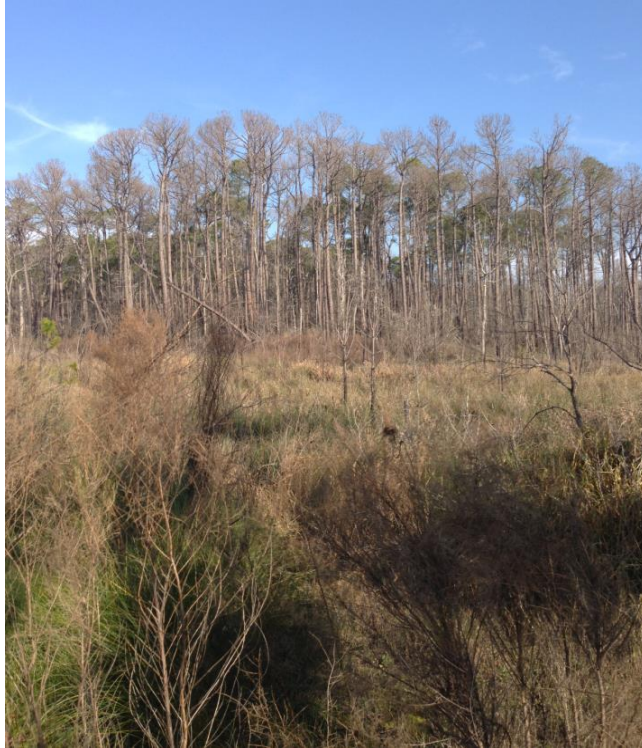
Figure 77: Dead pine trees on the eastern end of Dauphin Island

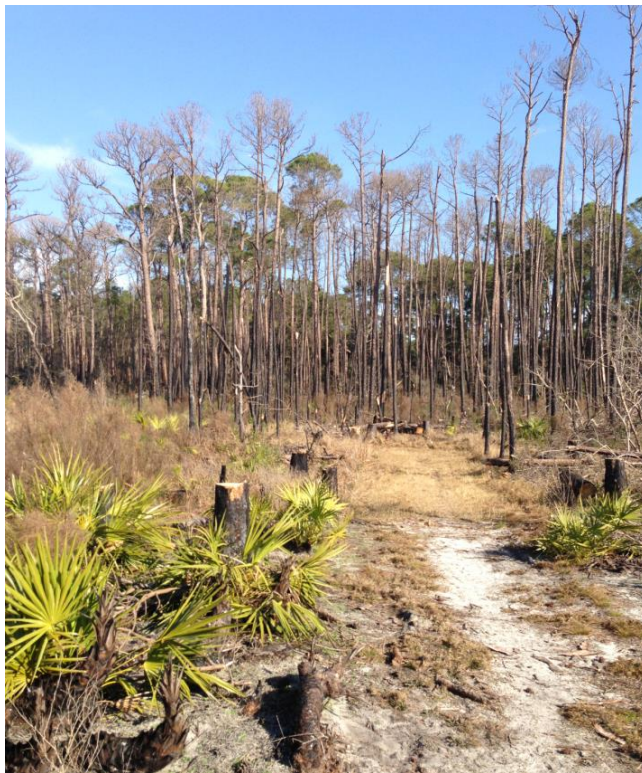
Figure 78: Dead and snapped pine trees in the southeastern portion of the bird sanctuary
